# **Asbestos Survey Report**

Ref: L-01406

**Old Lyric Hall  
Clifford Street  
Barrow in Furness  
LA14 2NJ**

*16 May 2023*

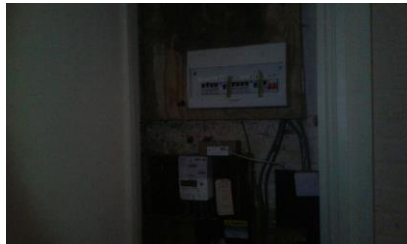
Old Lyric Hall		
Location/Item	Justification	Photo
Ground Floor, 001 Stairwell, Electrical Distribution,	Area inspected in detail and no suspected asbestos containing materials identified
